# INVESTIGATION OF THE CAUSE OF LIQUID MALDISTRIBUTION IN VACUUM DISTILLATION UNIT

## ABSTRACT

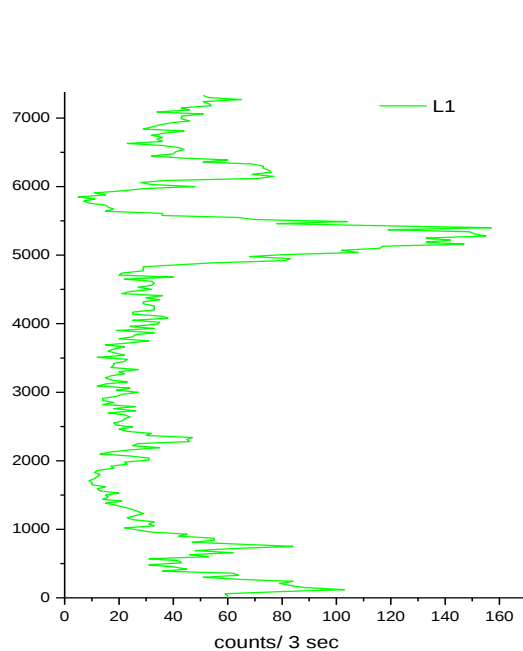
Fig 9: Scan line of the Chord L1

Scan Line L-1: Distributor is supplying proper liquid flow in this direction. In bed no. 3, presence of good amount of liquid is observed. However upper half shows lesser liquid than the lower half. Chimney tray and nozzle below show large quantity of liquid accumulation (Fig.9).

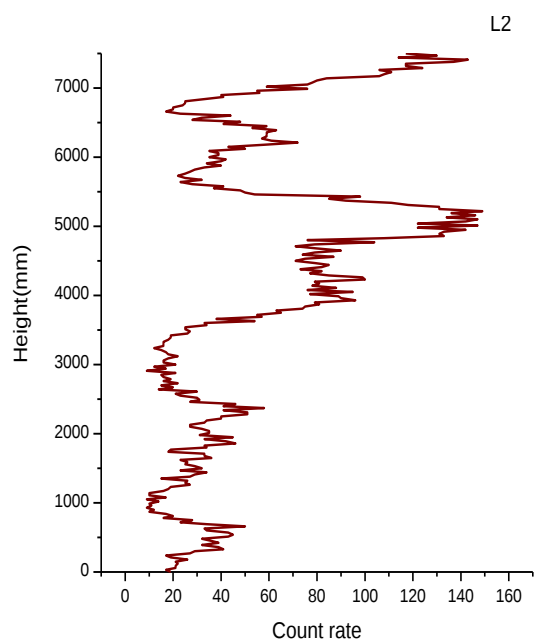
Fig 10: Scan line of the Chord L2

Scan Line L-2: Less liquid is seen falling from this direction from the distributor. Upper half of bed no. 3 is deprived of sufficient quantity of liquid. However some quantity of liquid is seen in the lower half of the bed. Good quantity of liquid seen in the chimney tray & nozzle below (Fig.10).

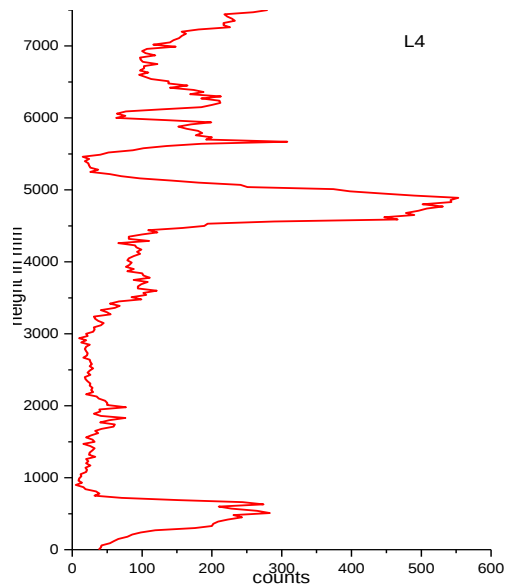
Fig 11: Scan line of the Chord L4

Scan Line L-4: In this direction, very less quantity of liquid is seen falling from the distributor. Upper half of the bed shows much less liquid. However in the lower half of the bed no. 3, good quantity of liquid is seen. Good amount of liquid is seen in the chimney tray up to the nozzle (Fig.11).

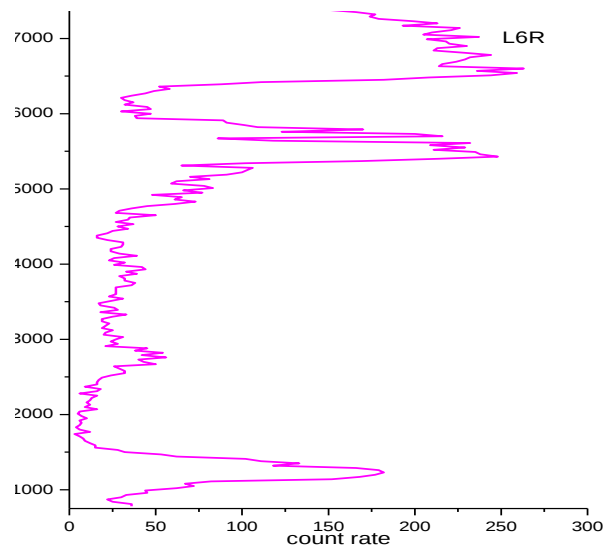
Fig 12: Scan line of the Chord L6

Scan Line L-6: Good quantity of liquid is seen falling from the distributor in this direction. Upper half of the bed no. 3, uneven liquid distribution is observed. In the lower half of the bed, good amount of liquid is observed. In the chimney tray, from nozzle to top of the chimney, liquid is seen (Fig.12).

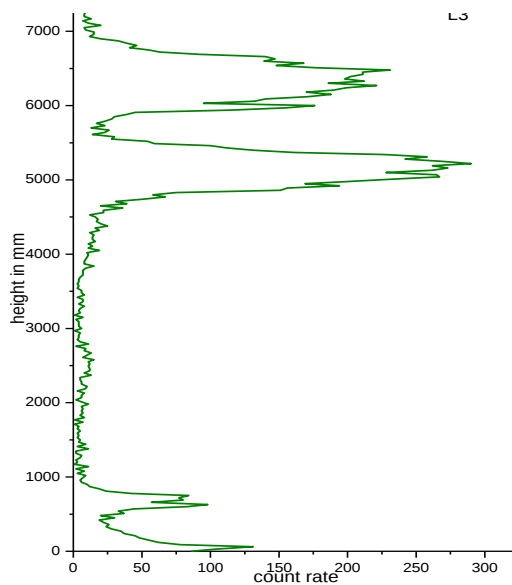
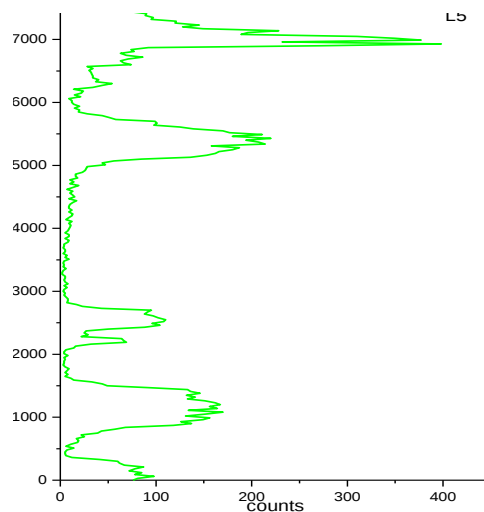
Scan Line L-3 & L-5: Less liquid is seen falling from distributor in the direction of diagonal L-3 whereas good quantity of liquid is seen falling from the distributor in direction L-5. In both L-3 and L-5 direction, good quantity of liquid is observed in bed no. 3 (Fig.13 and Fig.14).

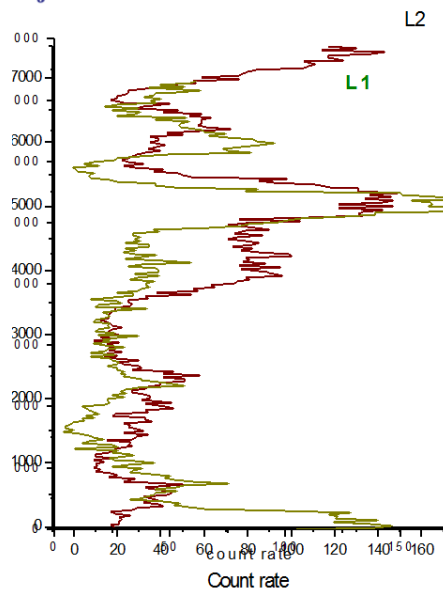
Fig 15: Comparison of Scan lines the Chords L1 and L2

Comparison of L-1 & L-2: Less liquid is seen falling from the distributor in the direction of L-2 as compared to L-1. First half of the bed no. 3, in the direction of L-2, much less liquid is observed than the direction of L-1. However in the lower half of the bed, even liquid distribution was seen (Fig.15).

| Sr. No. | Comparison of L-1 & L-2 |
|---|---|
| 1 | Less liquid is seen falling from the distributor in the direction of L-2 as compared to L-1. |
| 2 | First half of the bed no. 3, in the direction of L-2, much less liquid is observed then the direction of L-1. However in the lower half of the bed, even liquid distribution was seen. |

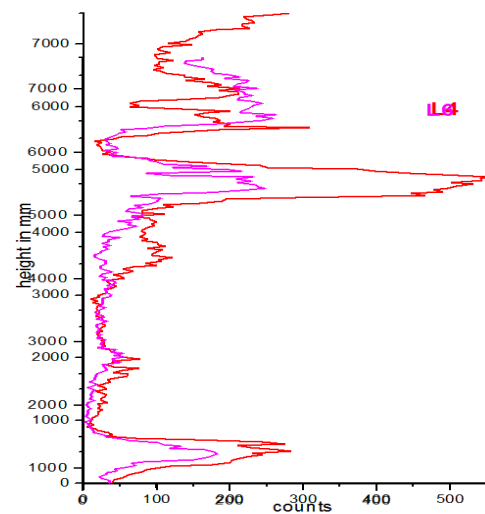
Fig 16: Comparison of Scan lines the Chords L4 and L6

Comparison of L-4 & L-6: Very low quantity of liquid was seen falling from the distributor in the direction of L-4 & good quantity of liquid was seen falling from L-6 direction. Upper half of the bed no. 3 in the direction of L-4 shows slightly better liquid than L-2 but less liquid than L-6. However in the lower half of the bed, liquid distribution is even throughout (Fig.16).

| Sr. No. | Comparison of L-4 & L-6 |
|---|---|
| 1 | Very low quantity of liquid was seen falling from the distributor in the direction of L-4 & good quantity of liquid was seen falling from L-6 direction. |
| 2 | Upper half of the bed no. 3 in the direction of L-4 shows slightly better liquid than L-2 but less liquid than L-6. However in the lower half of the bed, liquid distribution is even throughout. |

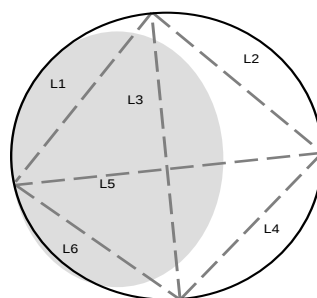
Fig.17. conceptual picture of liquid distribution

From all the above scan lines and interpretations derived from them a conceptual picture (Fig.17) of liquid distribution in the upper half of the bed no. 3 is developed. In the direction of L1, L5, L6 good quantity of liquid is observed falling from the distributor nozzles on the bed no.3. In the direction of L2, L3, L4 moderate or less quantity of liquid is observed falling from the distributor nozzles on the bed no.3. Since bed receives less liquid in the south and eastern directions upper half of bed no. 3 is deprived of liquid falling from the nozzles. However, even liquid distribution is observed in lower half of the bed. Scan lines in east and south direction show that even though upper portion of the bed receives less liquid there is no bearing on the attenuation implying much coking observed in this portion of the bed. Based on the above results it is concluded that there is no flow from distributor in the north and east portion of the column on the bed 3. The distributor is positioned horizontally, there is no significant coking in the packed bed 3 and no channeling is observed. The corrective actions can be taken for achieving the healthy operating conditions.

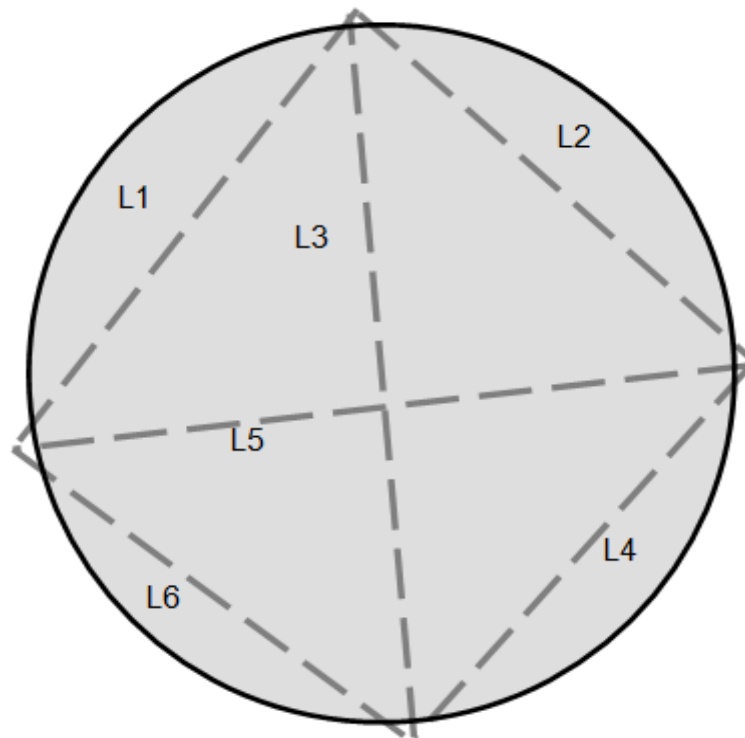
From all the above scanlines and interpretations derived from them a conceptual picture of liquid distribution in the upper half of the bed no. 3 is depicted as follows

- In the direction of L1, L5, L6 good quantity of liquid is observed falling from the distributor nozzles on the bed no.3
- In the direction of L2, L3, L4 moderate or less quantity of liquid is observed falling from the distributor nozzles on the bed no.3
- Since bed receives less liquid in the south and eastern directions upper half of bed no. 3 is deprived of liquid falling from the nozzles.
- However, even liquid distribution is observed in lower half of the bed
- Scanlines in east and south direction show that even though upper portion of the bed receives less liquid there is no bearing on the attenuation implying much coking is not observed in this portion of the bed

- There is no flow from distributor in the north and east portion of the column on the bed #3.
- The distributor is positioned horizontally
- There is no significant coking in the packed bed #3. No channeling is observed.

After the corrective actions are taken and the healthy operating conditions are achieved, it is recommended that signature scan of the column may be obtained and kept in the record for future reference.
