# PROPOSAL OF A SCHEME FOR CIRCULATION OF WATER IN THE TANKS OF BRAHMA SAROVAR AND SANNIHITH SAROVAR

Tadi Praveen<sup>1</sup>, Baldev Setia<sup>2</sup>

<sup>1,2</sup> Department of Civil Engineering, NIT Kurukshetra, (India.)

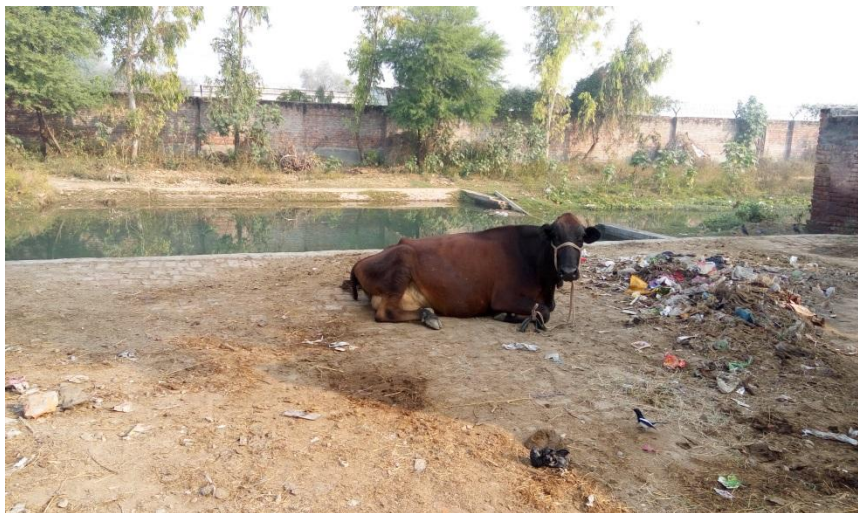
**Figure 3:** Cattle Farming at Mirzapur village

On its onward journey a total of 50 Cusecs of water is being carried by Thanesar Distributary which is an open channelled lined canal. Out of this 50 cusecs, 20 Cusecs are pumped into Brahma Sarovar and the rest 30Cusecs is carried forward for the purpose of cultivation and other needs. This canal on its way to Brahma Sarovarpasses through Mirzapur Village, Bhatta Colony and Kurukshetra University. In Mirzapur village it is being observed that the villages carryout cattle farming on the banks of the canal (fig 3) and it is also seen that they have dumped solid waste into the canal(fig 4). The canal before entering Kurukshetra University has a ghat where laundry work for a large number of clothes is carried out resulting in polluting the water with chemicals, detergents etc. (fig 5).

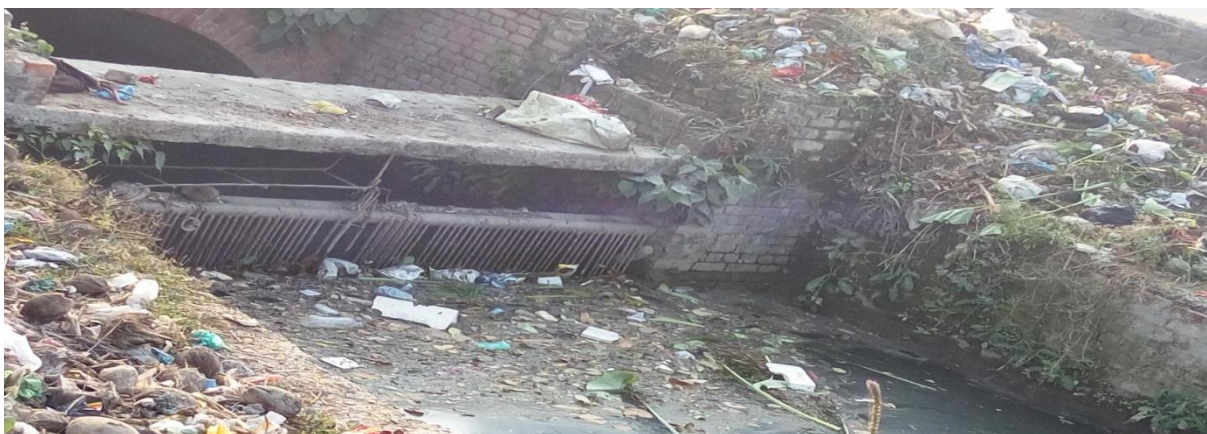
**Figure 4:** Garbage dumped in the distributary

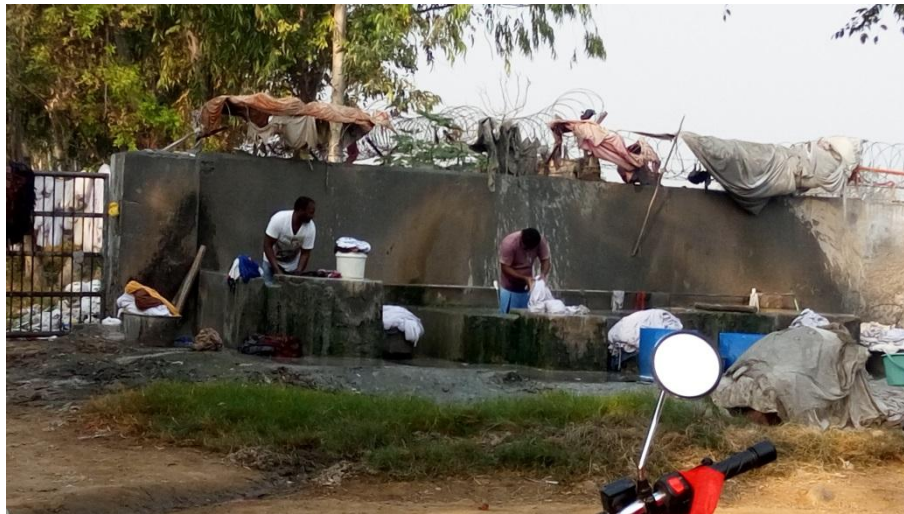
**Figure 5:** Laundry on the banks of distributary
