APPLICATION OF COAL COMBUSTION BY- PRODUCTS IN LEVEES

V. Mráz¹, M. Havlice², T. Horváthová³

Levees are geotechnical structures (among the earth structures of water management structures) built along rivers especially. Embankment dikes require processing of large volume of material, and because of that there is effort to find a suitable replacement for traditionally used materials. One option is the use of Coal Combustion By-Products (CBB). Levees with CBB were built in several quantities in Czech Republic. Realized structures generally with problem-free function are documented. In some cases, relating to flooding during June 2013 there has been a failure. The paper shows some cases of applications of CCB and summarization of the results of usage CBB in earth structures of water management in Czech Republic.

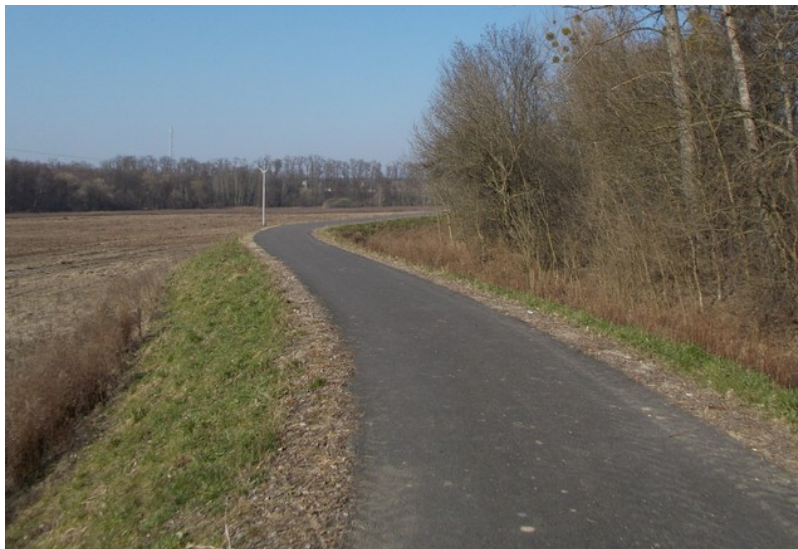
Figure 2: Levee with asphalt bicycle trail near the village Rohatec in the Hodonín

In the village Rohatec near Hodonin levees were built along the Morava River protecting the village against flooding (Fig. 2). Dam crest is headed 0.5m above the water level at the centennial water on the Morava River (Q_{100}). The height of the dam corresponds to similar dams (Skalická) on the Slovak side of the river. The dam is 1.271 meters long, inclined slope of 1:2 and a dam crest has width of 4 m. On the dam crest is built a lightweight construction of road (bike trail), width of 3.0 m with 0.5 m verge. The dam is designed as a continuous liner body with an inner solid core and the slopes of soil. Until the dam was applied to fly ash stabilizate REHAS EHO from near Hodonin power plant. Is the ash mortar, i.e. moistened mixture of bottom ash and fly ash (from fluidized bed combustion technology). The total volume of embankments amounts to 20.670 cubic meters.

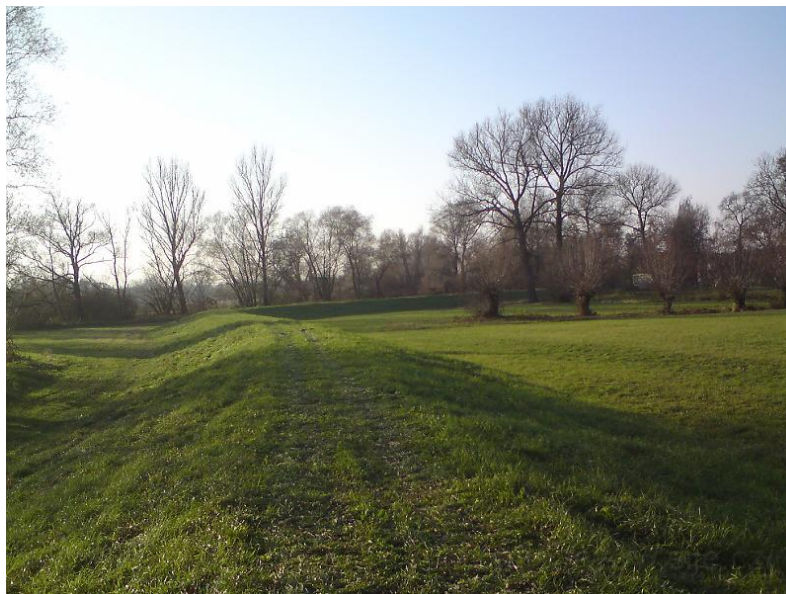
Figure 3: Completed levee near the village Nepasice (<http://reka-orlice.sije.cz/trebechovice-hradec-kralove>)

In the town of Hradec Kralove protective levees were implemented protecting the southern and southeastern part of the built-up area of the village before the flows in the river eagle until Q100. The total length of the dam is 530 m, height of about 1.20 to 1.80 meters. The investor of structure is the “Elbe River Basin”, state office (Fig. 3).

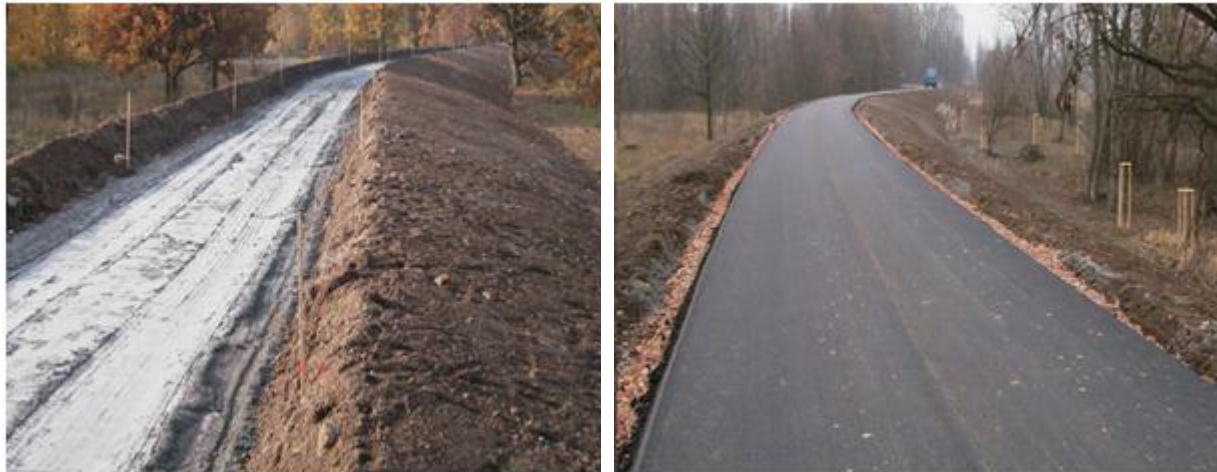
a) levee during construction

b) levee after construction

Figure 4: The levee with bicycle path using CCB in Pardubice (Power Plant Opatovice, 2014)

In Pardubice construction of the dam was used to seal the core of the CCB from a nearby power plant Opatovice. After the dam crest is led by asphalt road. The core of the dam is protected side stir. The amount of stored fly ash stabilizer amounted to 52.500 tons (Fig. 4).

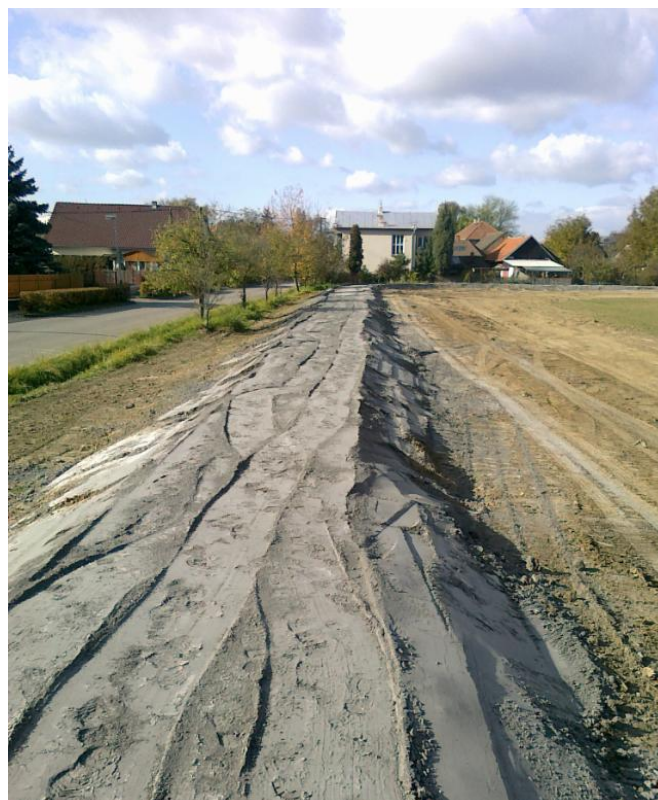
Figure 5: Vrды - Construction of Levee Using CCB (Power Plant Opatovice, 2014)

After previous experiences of urbanized area of town Vrды near Čáslav there was built levee in 2012, whose body is made up from ash stabilizate (Fig. 5). The dam has used 2.000 tons of fly ash stabilizate. In 2013, it successfully passed the river Doubrava spill and protect the village from flooding.

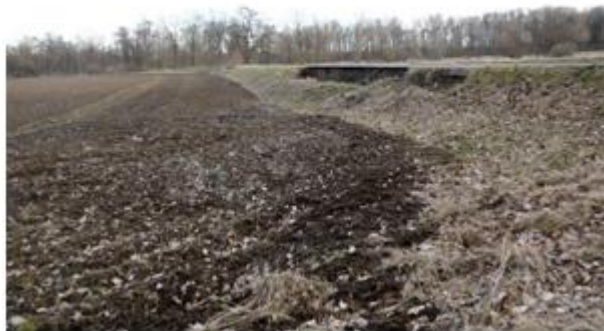
a) the greatest of the many failures of downstream face of the levees in the length of approximately 25 m

Figure 7: Failure of levee because of overtopping during the flood in 2013 (Mráz, 2013)

During the floods in 2013 there has been a breach this levee by overflow when exceeding of the design flow rate in the Vltava River. Water overspill violated in erosive action of downstream face of the dam (Fig. 7). In several places there was a shearing failure and landslide of the downstream face. Slide surface at the greatest failures to

hit below the crest of the dam, respectively under construction layer of asphalt bike trail. The total number of failures dam reached 90, but most were minor disturbances. On the slide surfaces is apparent that is different resistance against shearing failure in fly ash stabilizer (higher) compared with the soil layers when saturated with water.

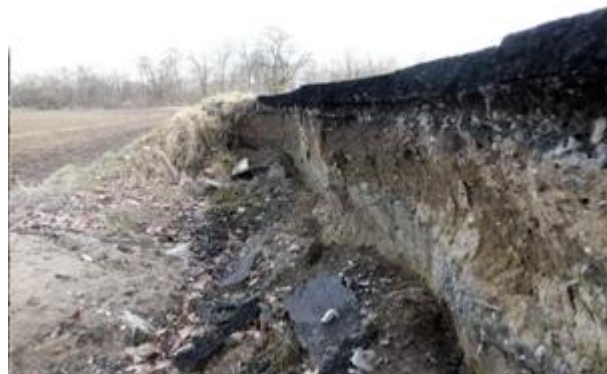
c) detail of exposed interior of the levee, including layers from fly ash stabilizer

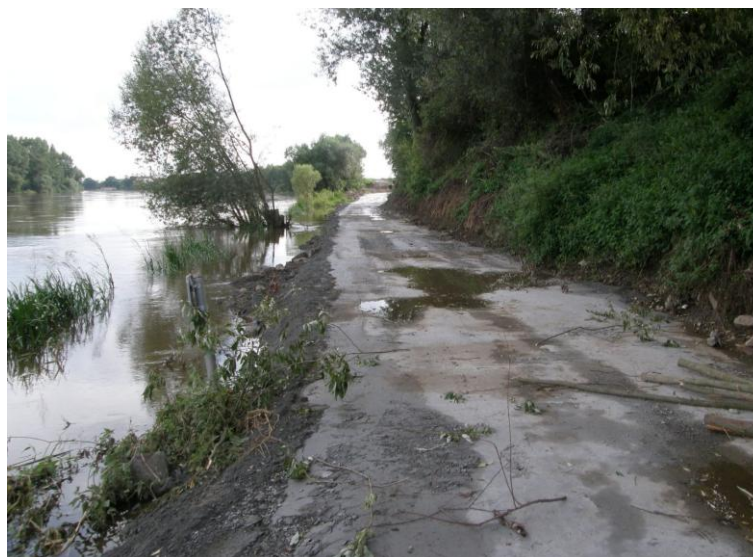
Figure 8: Flooding of base layer of still unfinished cycle paths from CCB during flooding (ČEZ a.s., 2013)

During the flood in 2013 there was overtopping of dikes and other places in the watershed of Vltava and Labe, respectively traffic roads using CCB as construction material (Fig. 8). There was no significant failures occurred, however. The difference between levee in Mělník and other structures consisted in using fly ash stabilizer greater extent, i.e. layers min. 40 cm or more. Layer of CCB at levee in Mělník is to maximal thickness of 25 cm.
