AN INVESTIGATION ON DISTRESSED CONCRETE

PILES BY PIT AND THEIR REPAIR AND RETROFITTING

Teke S.S¹, Dr.D.K.Kulkarni²

¹PhD Research Scholar, ²Professor, Department of Civil Engineering,
SDMCET, Dharwad, Karnataka,(India)

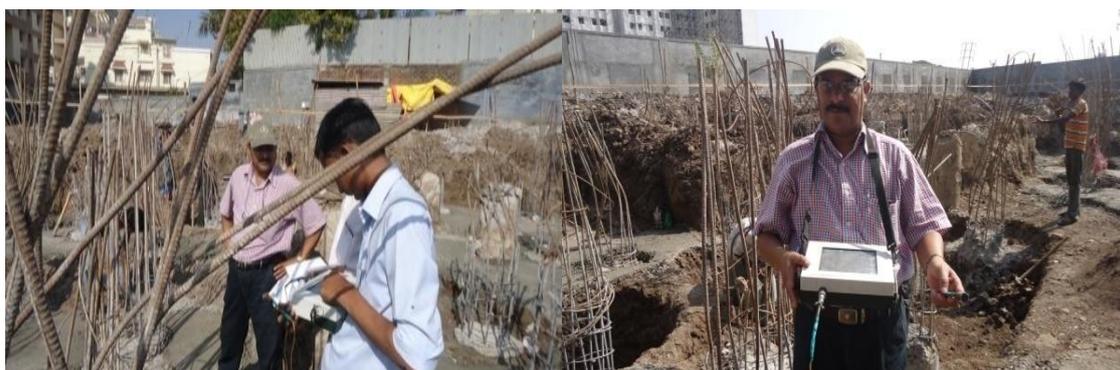
Fig. 3: Pile foundation at Pune Site. Fig. 4: PIT Test Equipment

Pile Integrity Test Method was proposed and performed on the exposed piles to obtain information on pile quality and its length. In all 150 piles were tested. Fig.3. shows pile foundation at Pune site and Fig.4. shows PIT test equipment.

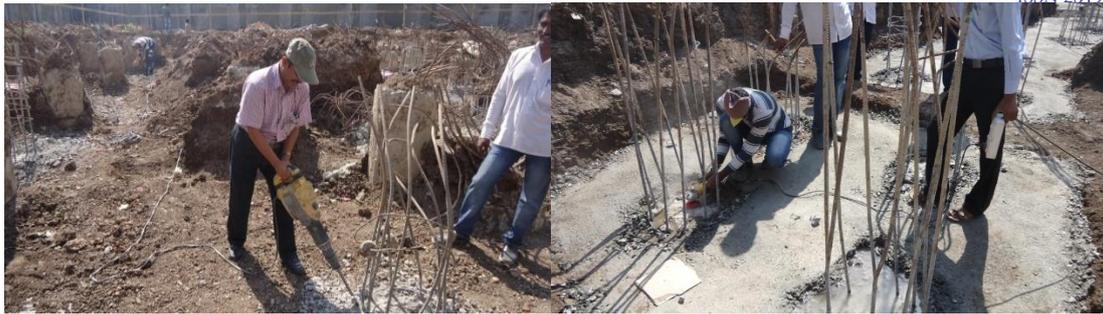
Fig. 5: Breaking of damaged pile portion

Fig. 6: Pile top grinding process

To conduct the test successfully some initial preparations were carried out. Loose, contaminated or damaged concrete was removed by concrete breaker. Fig.5. shows braking of such damaged pile portion. To make a firm contact of accelerometer with concrete pile top, grinding process was carried out and then a thin layer of petrowax or Vaseline between pile top and accelerometer was applied. Fig.6. shows such pile top grinding process.

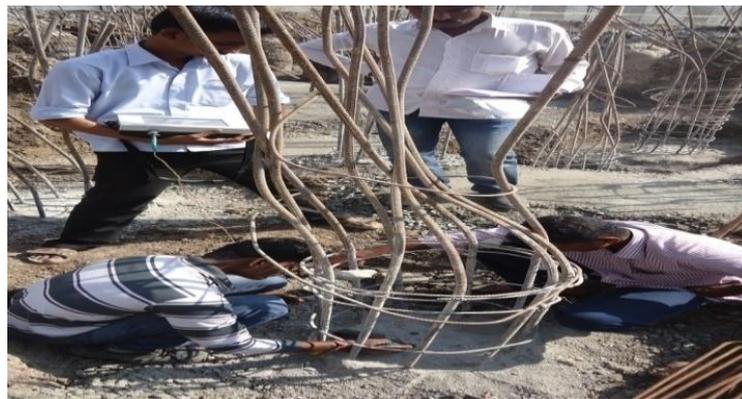
Fig. 7: Pile Integrity Test in progress

After this preparation, an impact with the hand held hammer is applied. The impact typically generates accelerations in the 10 to 100 g range, pile strains around 10^{-5} , velocities near 30 mm/s, and displacements less than 0.03 mm. Accelerations produced by several hammer blows are integrated and displayed as velocities on the processor's screen. Consistent records are selected, averaged, scaled and then redisplayed. Averaging reinforces the repetitive information from pile or soil effects while reducing random noise effect [4]. Fig. 7. shows Pile Integrity Test in progress. The test has been standardized as per ASIMD-5882 and is also a part of the Draft Indian specification IS: 2911 [5].

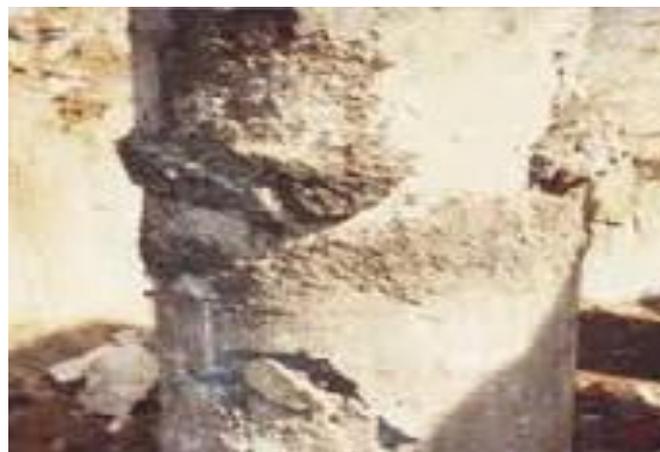
Fig. 11: View of defective pile after excavation.

1. Excavate the defective pile as indicated by PIT method.
2. Excavation confirmed the defect was nearly at a depth of 4.9 m from top of pile which can be seen in PIT record at about 5m depth.

3. Break and remove the defective zone by breaker in combination with chisel. Clean dust and removing loose material from the defective zone.

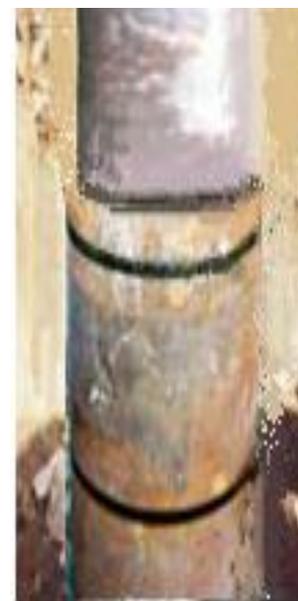
Fig.13. pouring of epoxy grout in an envelope of jacket.

5. Fix the position of jacket properly and check the plumb and pour the FX-70-6 Hydro-Ester Multi-Purpose Marine Epoxy Grout mixed in a proportion 2A:1B, where A and B are the grout chemical components given by manufacture. Fig.No.13 is a view of defective pile after pouring of epoxy grout in an envelope of jacket.[7]

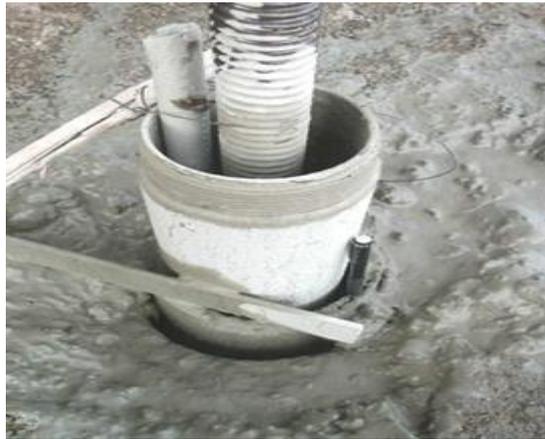
Fig.16 : Installed micro pile.

A 30 mm diameter Dywidag steel bar and grout sleeve were placed in the center of the hole before the grout had set. The anchor zone was pressure-grouted through the grout sleeve under a low pressure. The purpose of pressure grouting the pile was to insure that the grout filled all voids and created an effective cylindrical bulb in the anchor zone, resulting in high values of skin friction between the pile and soil. After grouting the required grouted length, the inside part of the steel pipe is filled with the same cement grout. Fig 16 is a view of installed micro pile. At the location of the new column, a new pile cap was poured directly over the micro-piles including existing pile.
